**Flood Control Project Maintenance
Levee Inspections**

Fall 2009 Levee Maintenance Deficiency Summary Report

San Joaquin River Basin

Lower San Joaquin Levee District

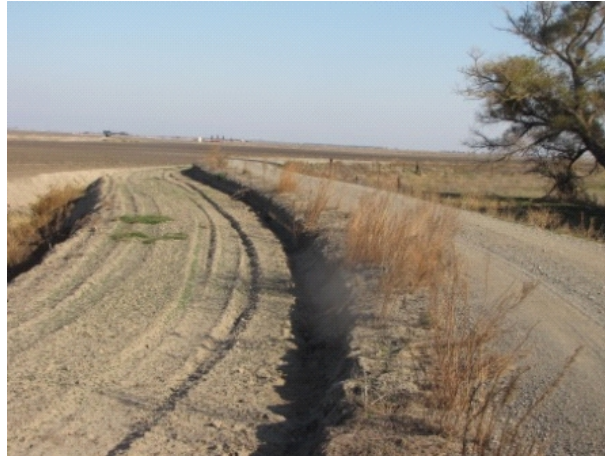
richard_20091123_111.jpg

Looking north at farmer cutting into levee at landside toe.

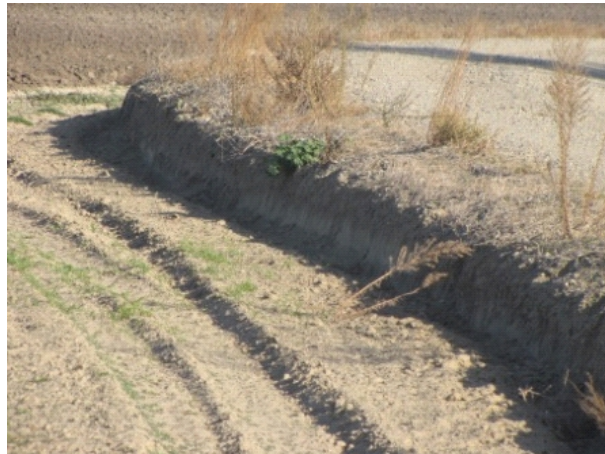
richard_20091123_112.jpg

Levee Mile Report Line	4
Start Levee Mile	21.44
End Levee Mile	21.50
Location	Land Side
Category	Earthen Levee
Item	Encroachments

Looking north at landside toe.

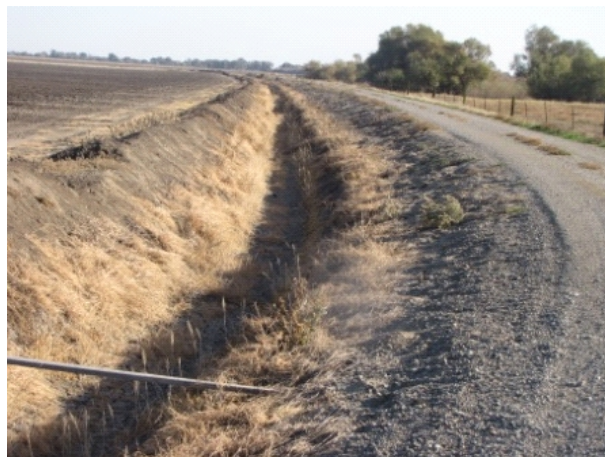
richard_20091123_113.jpg

Levee Mile Report Line	5
Start Levee Mile	22.21
End Levee Mile	22.52
Location	Land Side
Category	Earthen Levee
Item	Encroachments

Looking at landside ditch at levee toe.

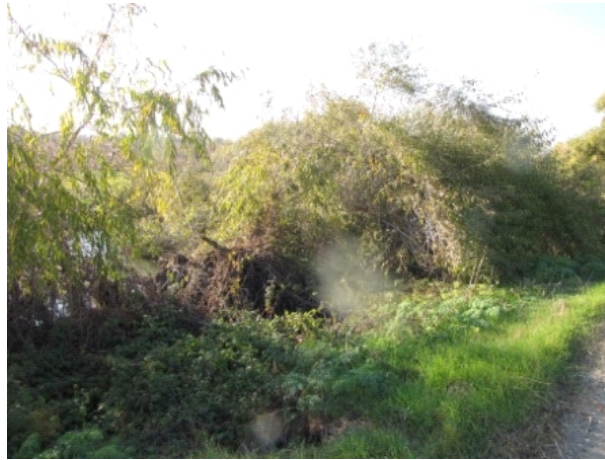
richard_20091123_115.jpg

Looking northwest at down tree on landside slope.

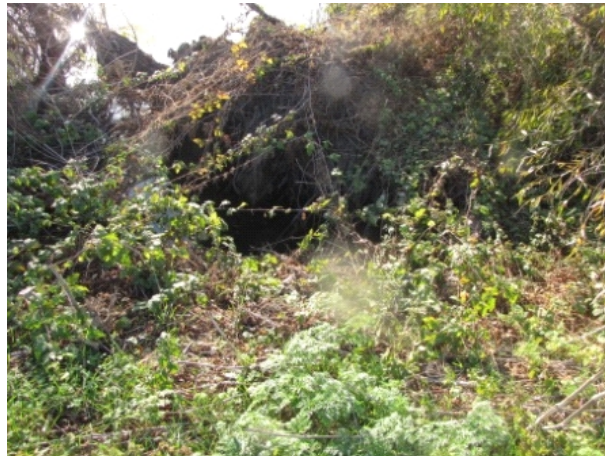
richard_20091123_116.jpg

Levee Mile Report Line	4
Start Levee Mile	13.05
End Levee Mile	13.05
Location	Land Side
Category	Earthen Levee
Item	Encroachments

Looking at hole left from down tree on landside toe.

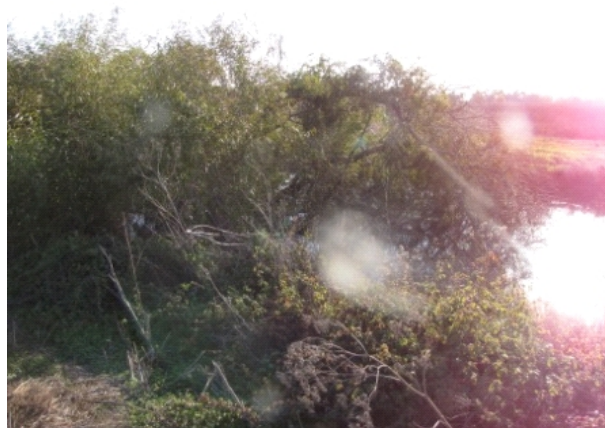
richard_20091123_117.jpg

Levee Mile Report Line	4
Start Levee Mile	13.05
End Levee Mile	13.05
Location	Land Side
Category	Earthen Levee
Item	Encroachments

Looking southwest at down tree in canal on landside slope.

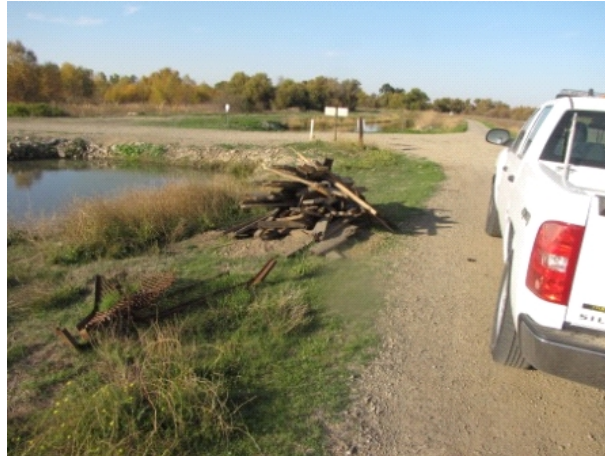
richard_20091123_114.jpg

Looking northwest at wood pile on landside shoulder.

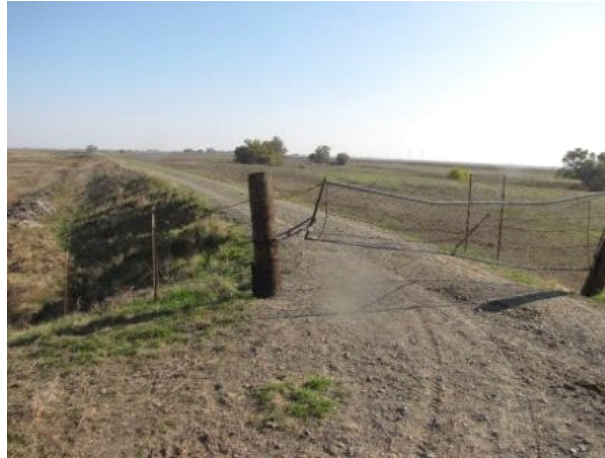
richard_20091123_118.jpg

Levee Mile Report Line	2
Start Levee Mile	6.58
End Levee Mile	6.58
Location	Crown
Category	Earthen Levee
Item	Repair Gates

Looking south at damage gate.

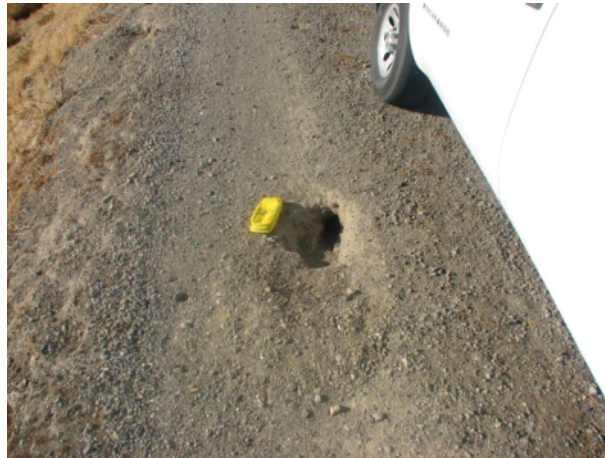
richard_20091110_107.jpg

Looking at squirrel hole at crown of levee.
